THE CHURCH OF THE THREE CROSSES IS AT RISK

26.1.2020

arkkitechdit mustonen oy / Niina Svartström, Architect

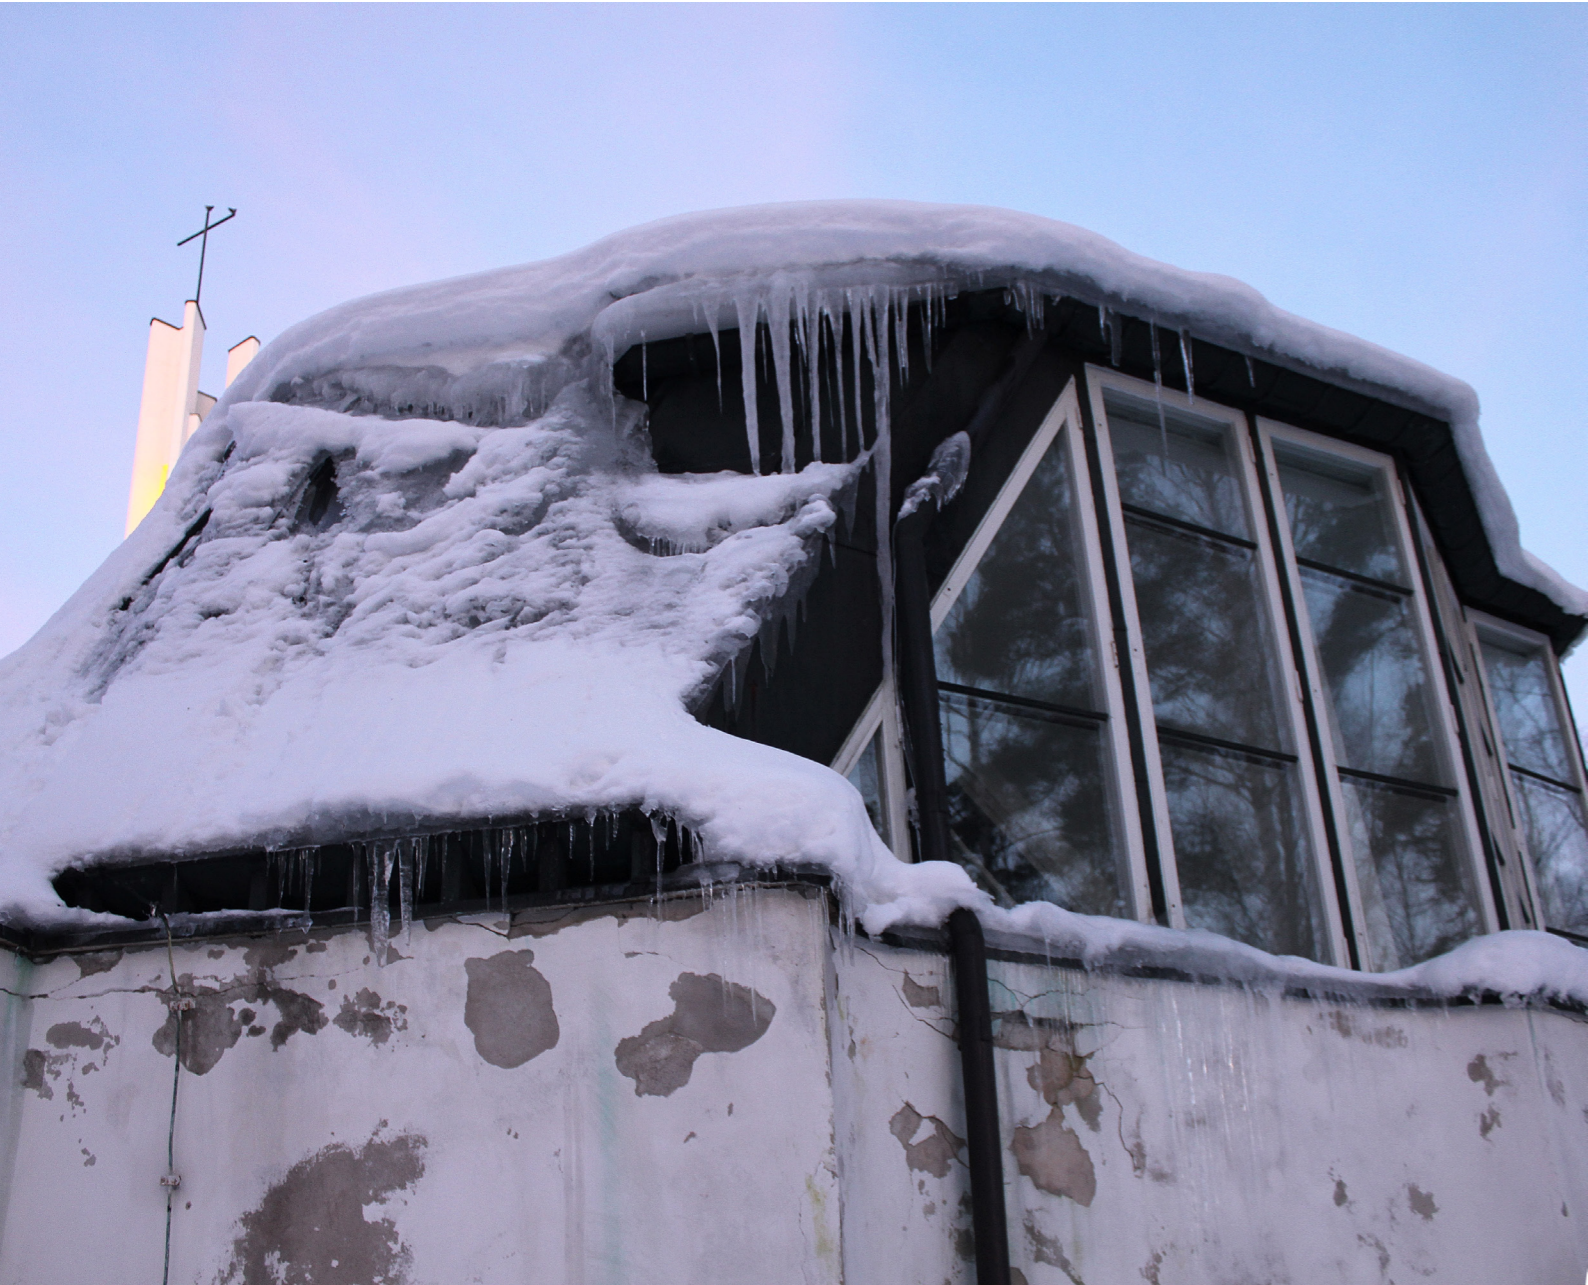
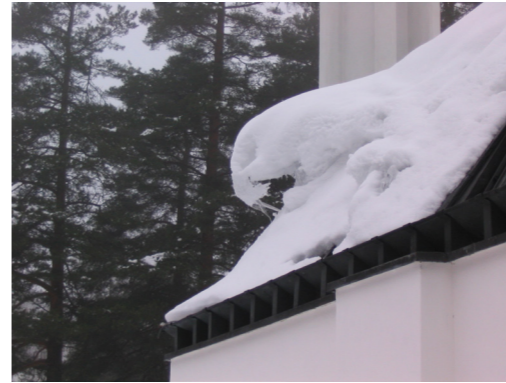
- ↑ Ice and snow form sculptural forms on the church facades, due to heat-loss through the thin concrete vaults.
- ← The eastern facade in 2012. Physical deterioration, plaster cracking and deformed copper eaves on the facades.

The copper roofing is leaking, the copper eaves are deformed and the facade plasterings are cracking, because of moisture issue. Some nude bricks are visible under the sheet-copper gutters. Cosmetic repairs are a nearly annual task in maintaining the façade, said the parish sacristan, but they do not solve the moisture issues.

The roof-eaves and gutters need to be repaired in their entirety and provided with ventilation gaps. Some later changes need to be rebuilt according to original details, as they have compromised both the architecture and constructional function. When the roof is secured, the presently damaged brick-facades can be repaired and replastered.

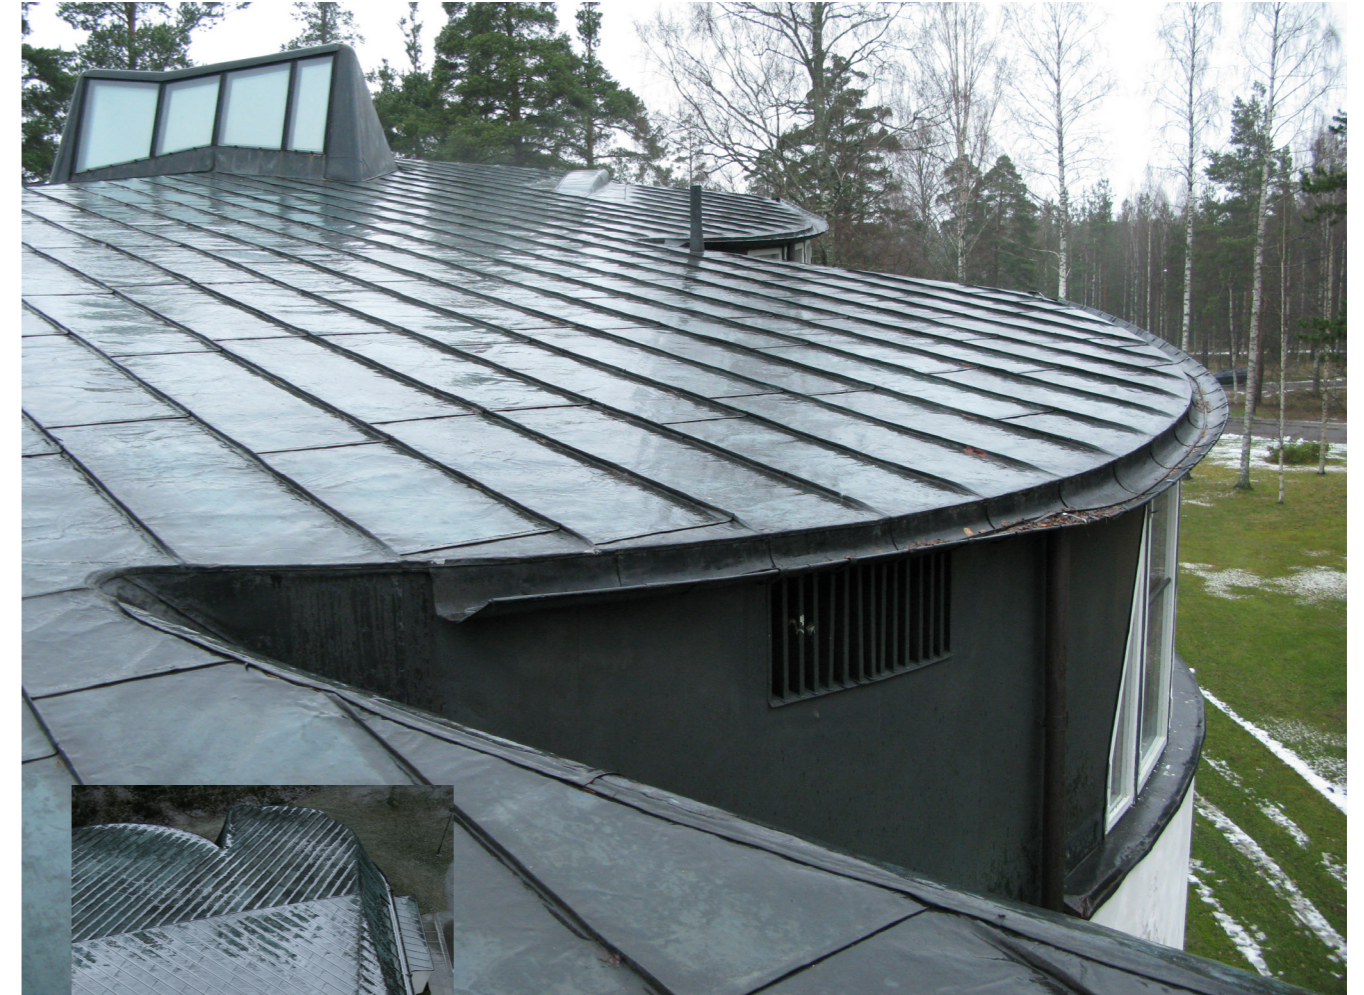
- ↑ The window sills and copper gutters have been deformed by ice and snow on all facades, but the eastern facade has the most challenging forms.
- ← View from the church tower.

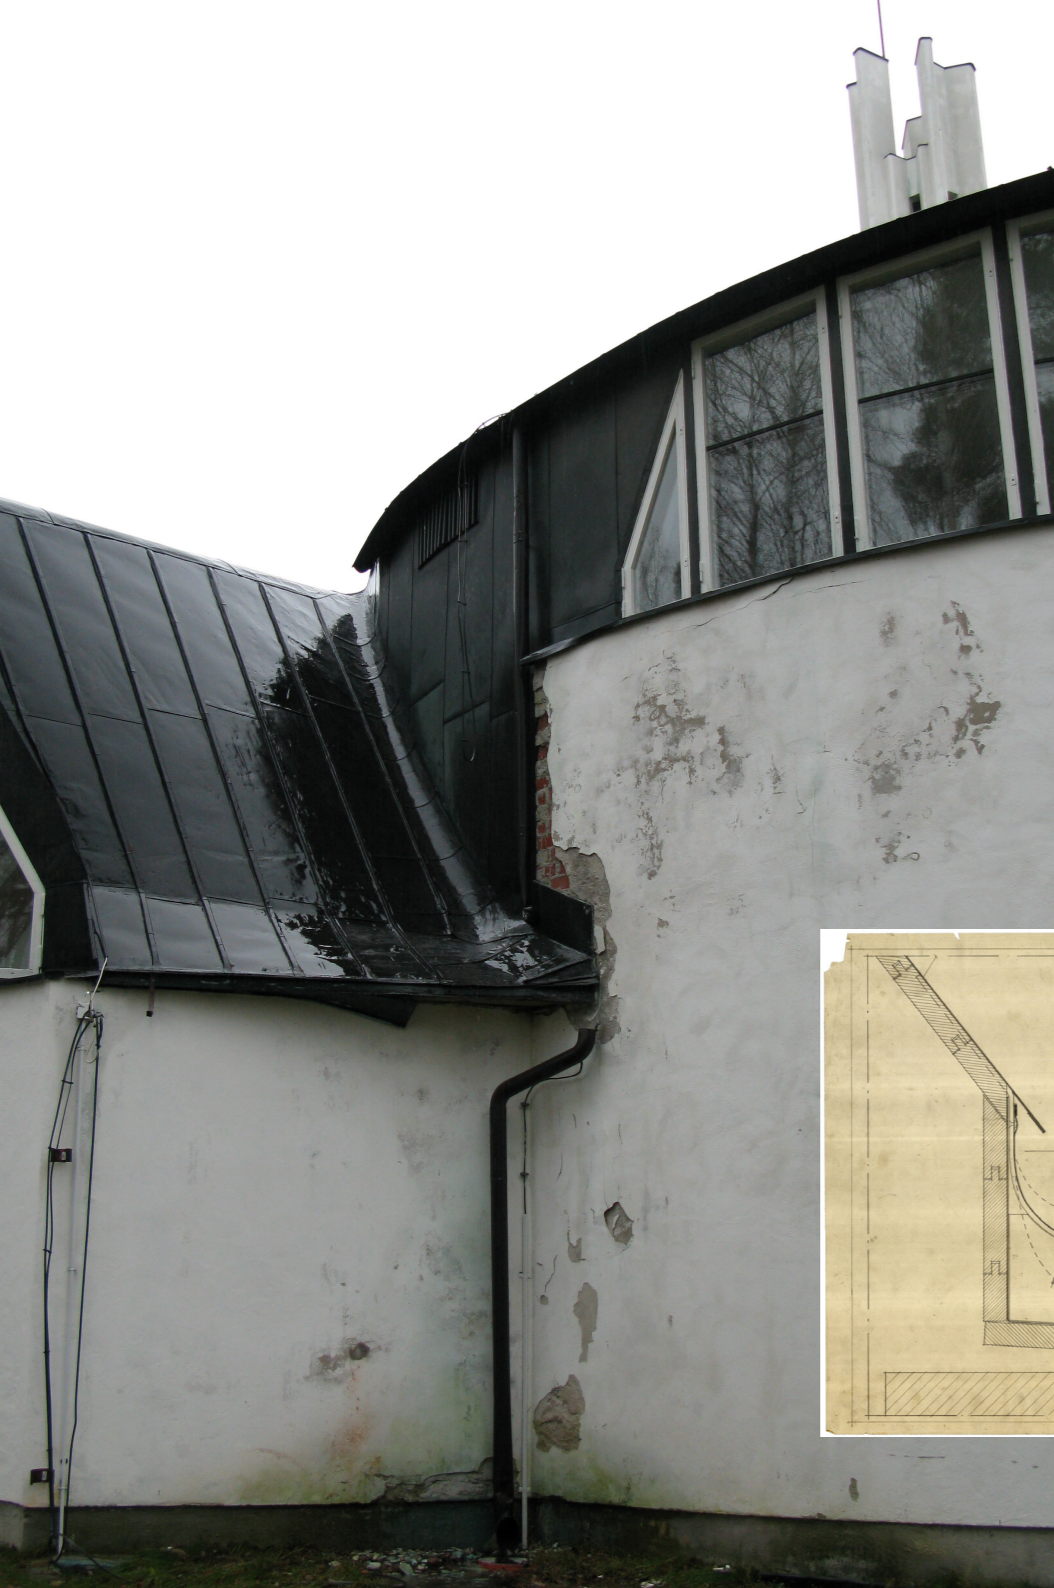
- ← The copper eaves on the eastern facade as found in November 2013. It had been altered, possibly due to repeated icing problems and deformations. This part of the roof eaves was chosen to make a tentative repair of the gutter in 2016.
- ↓ The copper eaves and gutter as shown on the original working drawing number 173 by Aalto on 25th of January 1957.
© Alvar Aalto Foundation

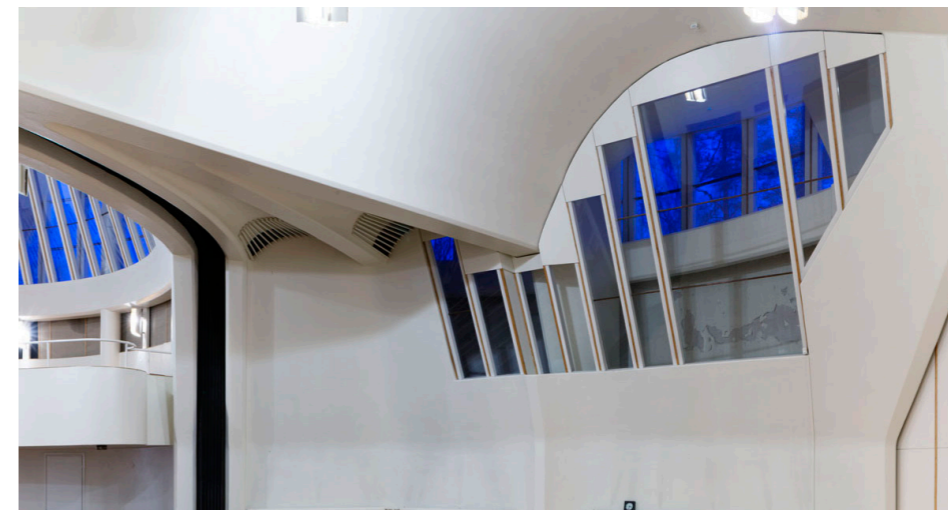
- ← The facade plasterings have been cracking on the outside since the church was built, but in 2018 pictures the moisture damages have become visible on the inside walls as well. © Alvar Aalto Foundation/ Pinja Eerola 2018.

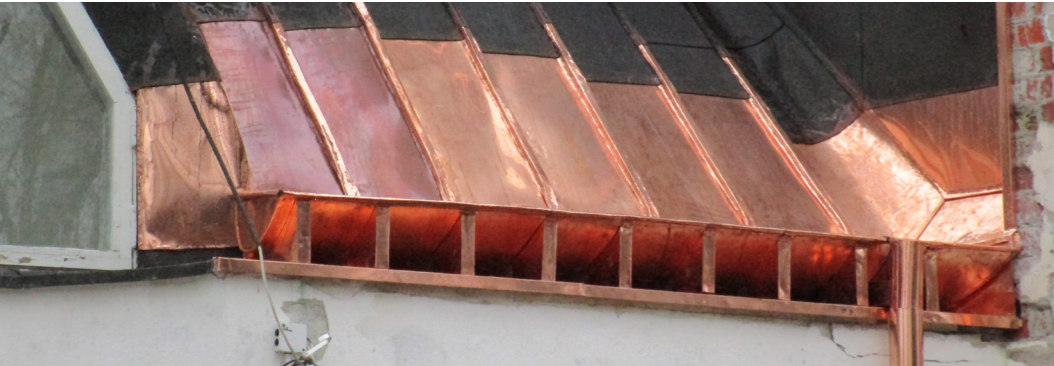
- ← The eaves on the eastern facade after a tentative reparation in November 2015. The aim was set to restore the form of the roof as well as to open a proper ventilation gap, which had been neglected in the earlier repairs as well as in the original construction. © The Imatra Parish/ Jari Nousiainen
- A new copper lattice was added to North-Eastern corner to enhance ventilation under the copper-roof.

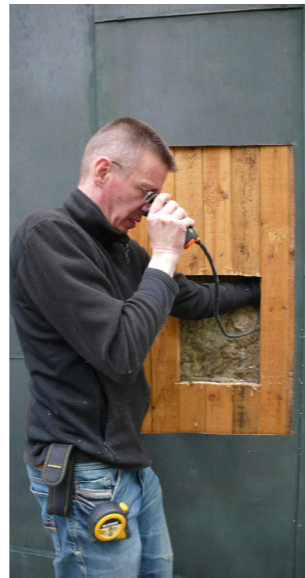
- ↑ Endoscopy of the roof structures by engineer Heikki Möttönen in May 2013.

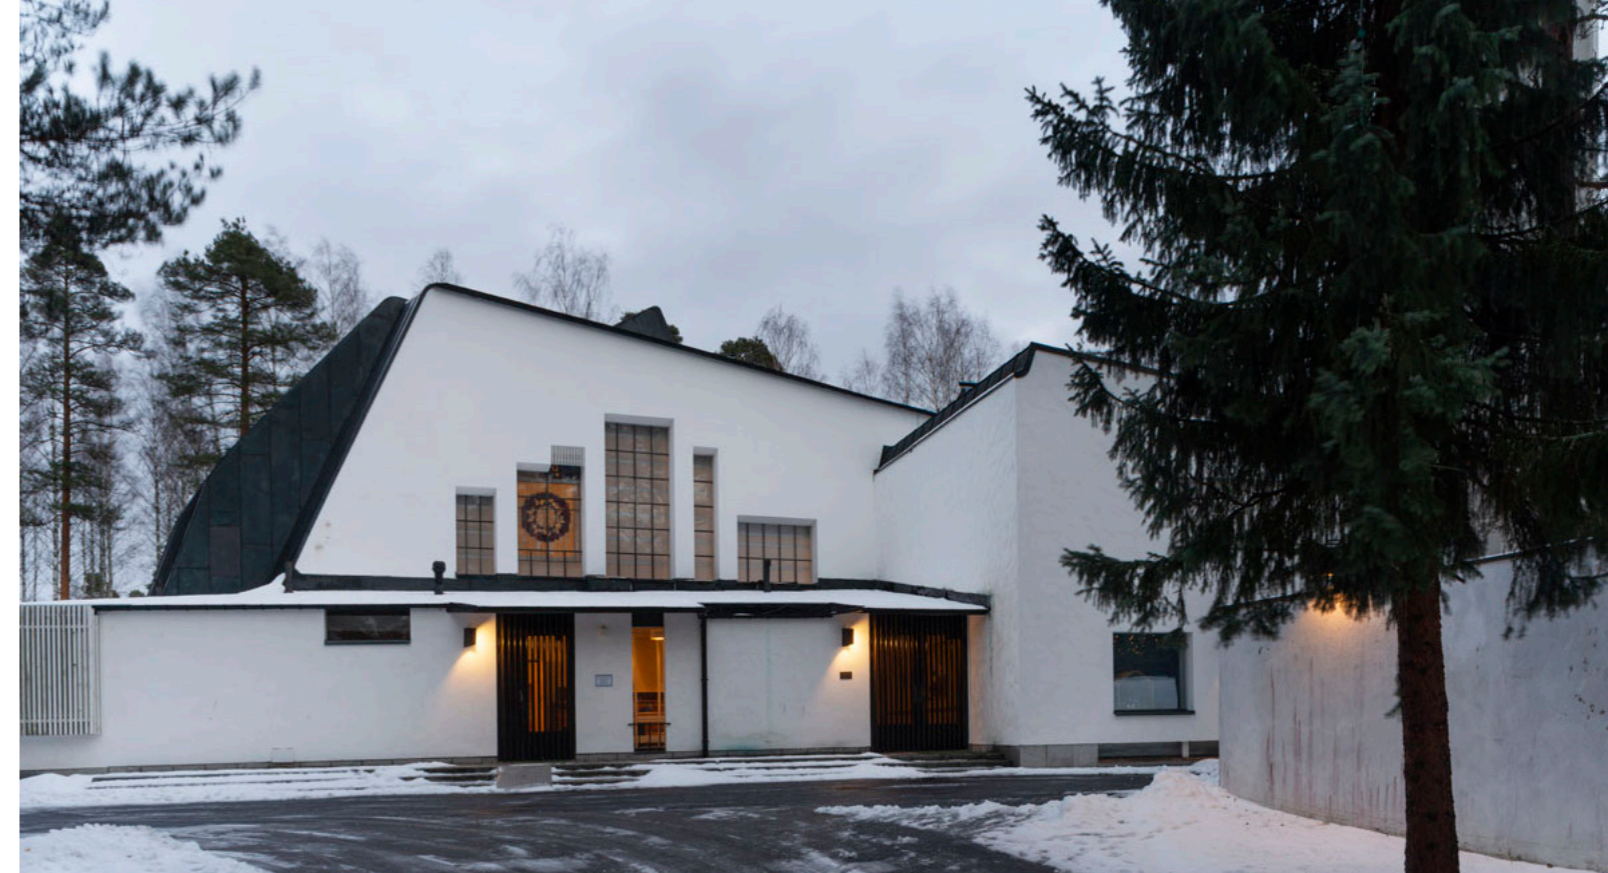
- ↑ Between 2016–2018 the southern entrance granite slabs were removed, and the concrete slabs underneath were recast and moisture insulated. Water had been flowing through under the treshold cut in stone.
- The facade in December 2018. One of the original courtyard light fixtures in copper was repaired and re-installed on the courtyard wall. © Alvar Aalto Foundation/ Pinja Eerola 2018.

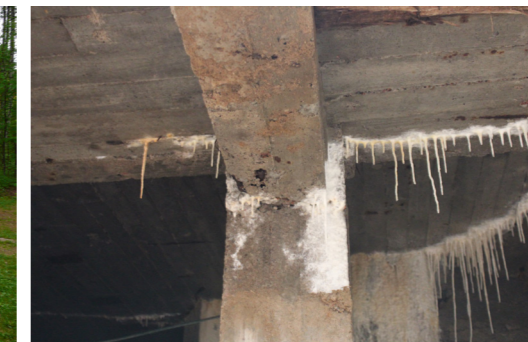
↓ Degraded concrete had grown calcium carbonate stactites beneath the concrete slabs. This is a result of calcium hydroxide being leached from concrete.

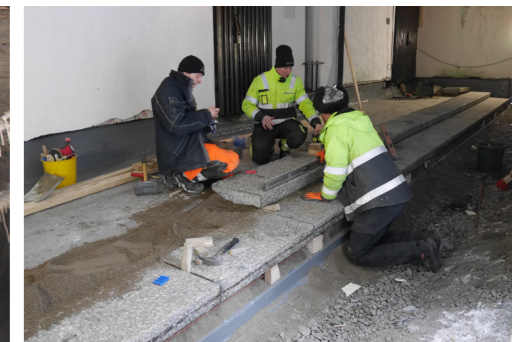
↓ Between 2016–2018 the western entrance slabs have been removed, the concrete structures recast and moisture insulated.

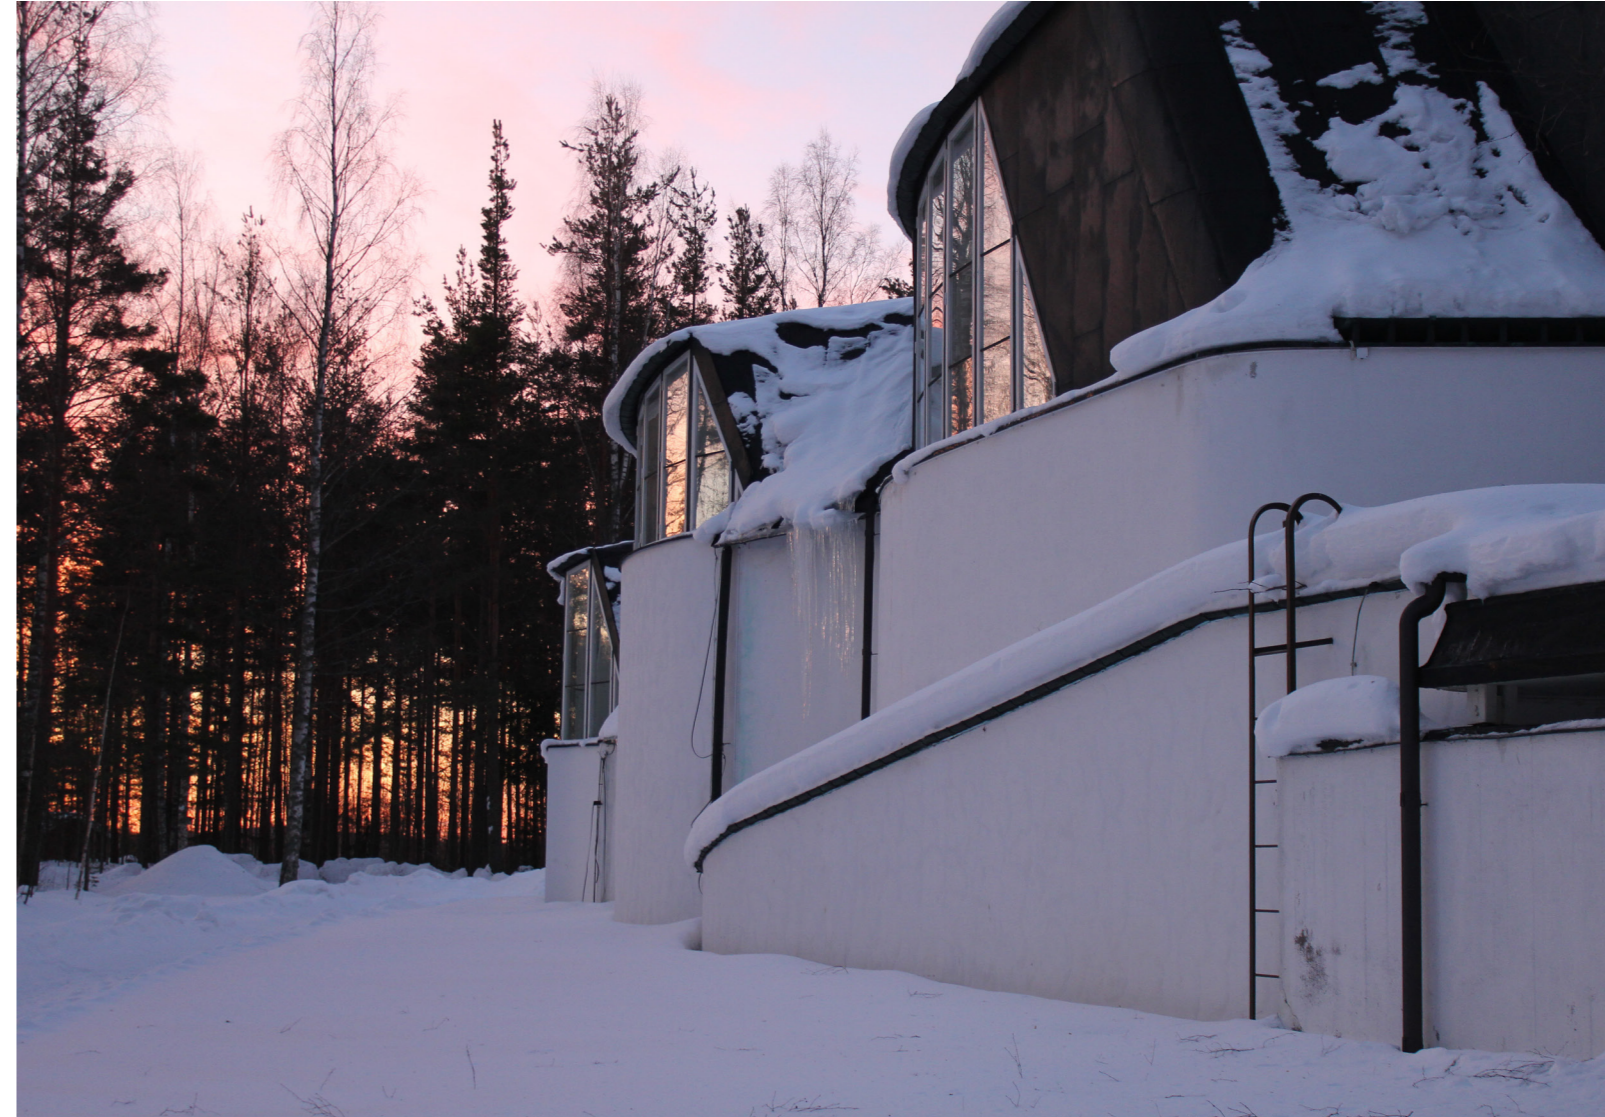
→ The eastern facade in February 2015.
