THE CHURCH OF THE THREE CROSSES IS AT RISK

26.1.2020

arkkitechdit mustonen oy / Niina Svartström, Architect

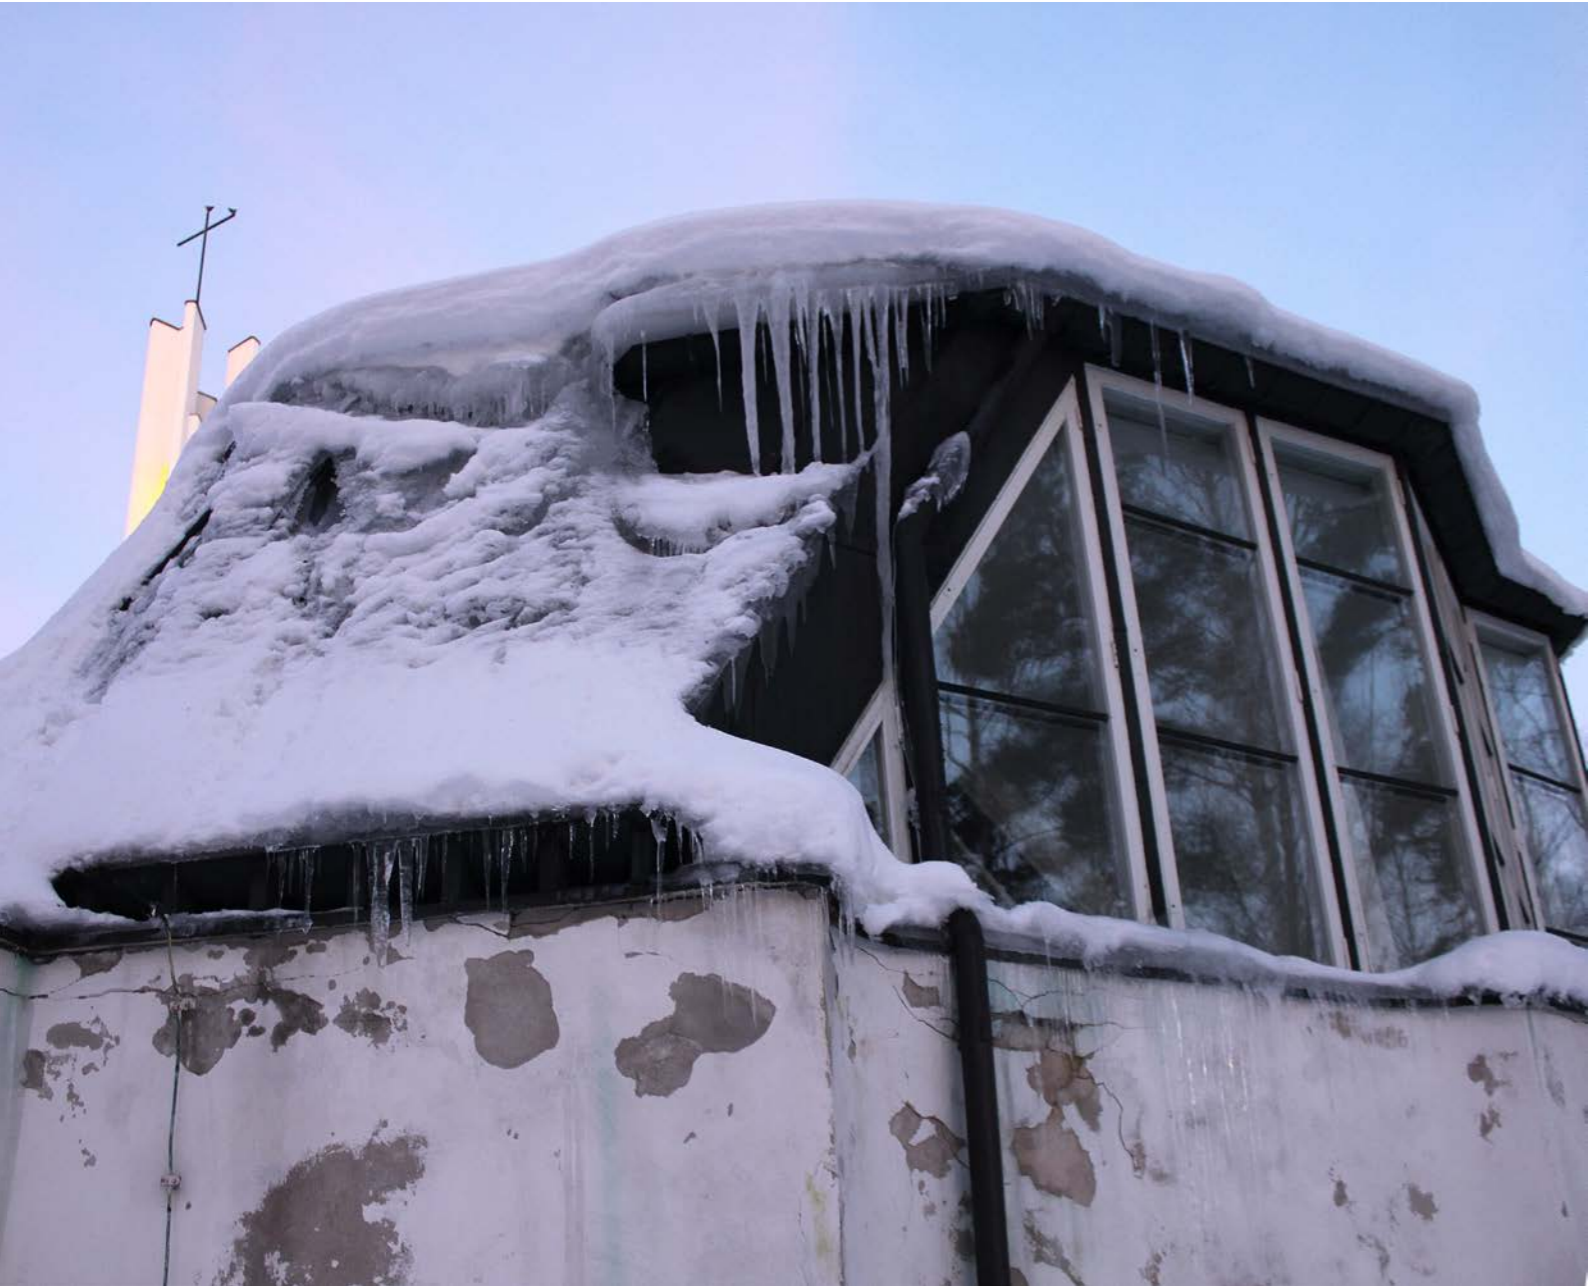
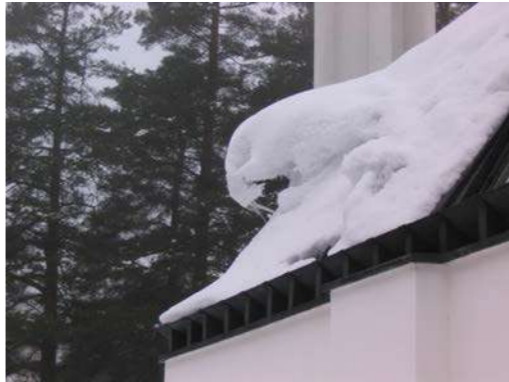
↑ Ice and snow form sculptural forms on the church facades, due to heat-loss through the thin concrete vaults.
← The eastern facade in 2012. Physical deterioration, plaster cracking and deformed copper eaves on the facades.

- ↑ Ice and snow form sculptural forms on the church facades, due to heat-loss through the thin concrete vaults.
- ← The eastern facade in 2012. Physical deterioration, plaster cracking and deformed copper eaves on the facades.

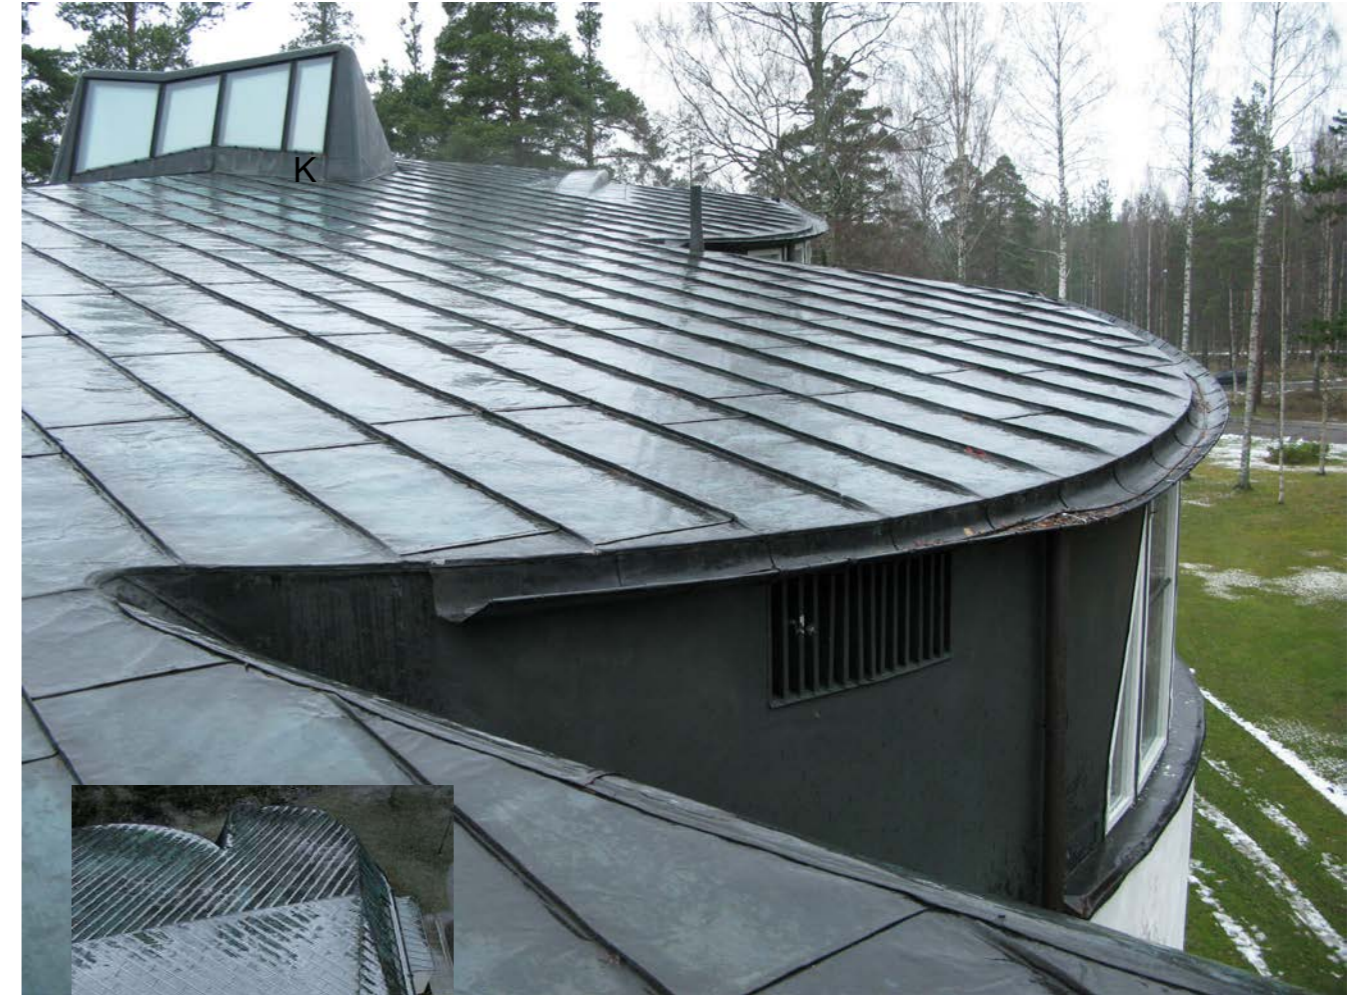
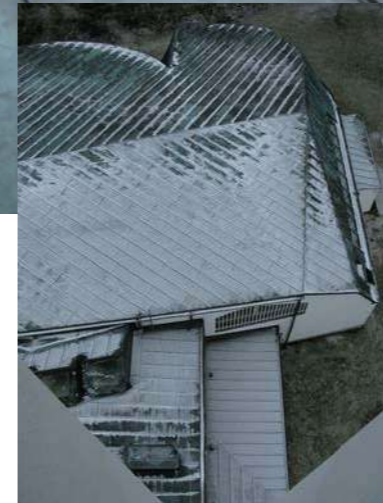
- ↑ The window sills and copper gutters have been deformed by ice and snow on all facades, but the eastern facade has the most challenging forms.
- ← View from the church tower.

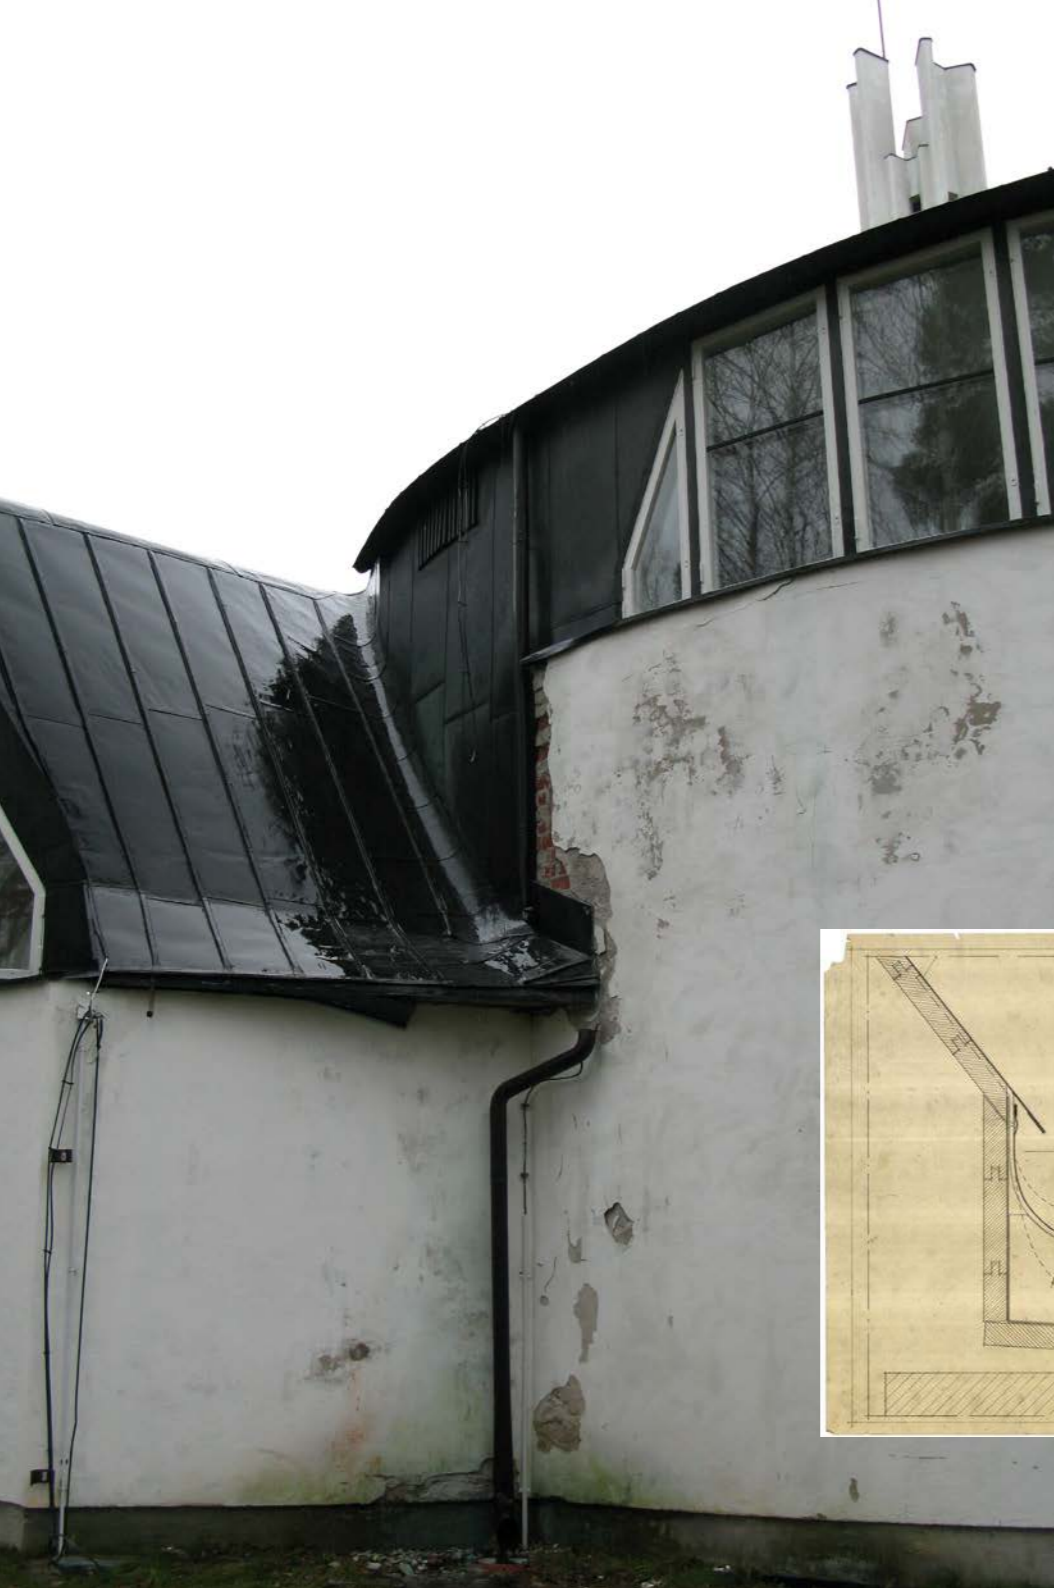
← The copper eaves on the eastern facade as found in November 2013. It had been altered, possibly due to repeated icing problems and deformations. This part of the roof eaves was chosen to make a tentative repair of the gutter in 2016.

- ← The copper eaves on the eastern facade as found in November 2013. It had been altered, possibly due to repeated icing problems and deformations. This part of the roof eaves was chosen to make a tentative repair of the gutter in 2016.
- ↓ The copper eaves and gutter as shown on the original working drawing number 173 by Aalto on 25th of January 1957.
© Alvar Aalto Foundation

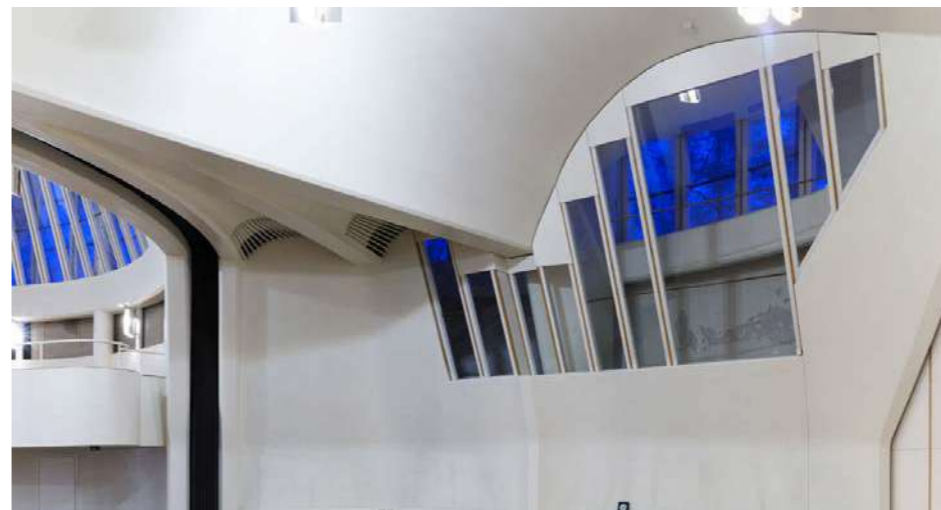
← The facade plasterings have been cracking on the outside since the church was built, but in 2018 pictures the moisture damages have become visible on the inside walls as well. © Alvar Aalto Foundation/ Pinja Eerola 2018.

- ← The facade plasterings have been cracking on the outside since the church was built, but in 2018 pictures the moisture damages have become visible on the inside walls as well. © Alvar Aalto Foundation/ Pinja Eerola 2018.

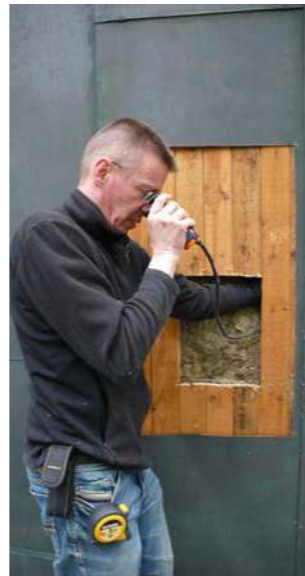
↑ Endoscopy of the roof structures by engineer Heikki Möttönen in May 2013.

- ↑ Endoscopy of the roof structures by engineer Heikki Möttönen in May 2013.
